SAFETY ALERT

UK SA06/2021 – 10.06.21

HIPO – ARTICULATED TRUCK ROLLOVER (SOFT VERGE)

LOST TIME INJURY – FRACTURED LEG

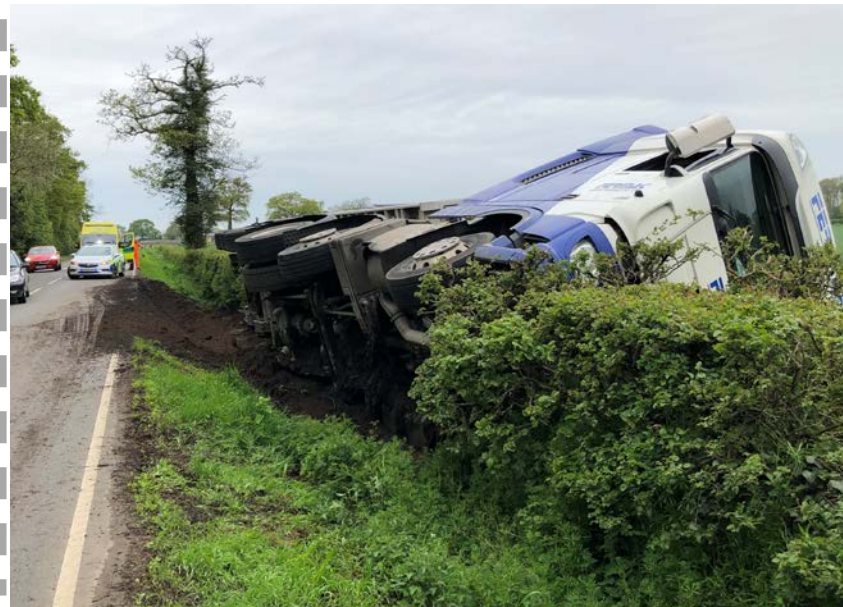
An articulated tipper truck, loaded with clay, rolled over when it veered off the road onto the soft verge. The vehicle ended up on its side in the hedge of a farmer's field. The driver is reported to have had a sneezing fit immediately prior to the incident. No other vehicle was involved and the driver was uninjured and passed the police checks (Breath test, etc.)

- The driver had been supporting the haulier, who have the clay contract, for the previous 8 days, completing 38 deliveries via this route
- The driver was wearing his seatbelt, which helped avoid injury
- Tacho suggests the driver was travelling at 35mph, well within the 50mph limit when the accident occurred
- The driver had 11.5Hrs continuous rest prior
- The driver has held his Class 1 HGV license for 13Yrs with no notable accident history
- Weather was dry, visibility good, the road was wet
- Mobile phone checks confirm not in use while driving
- The driver suffers from hay fever and takes (non drowsy) medication
- This is the 3rd almost identical incident in the last 6 years which has involved our clay fleet, plus many other none CEMEX related incidents on this route

- Consider whether alternative routes are available that avoid known local hazard spots.
- Confirm Driver inductions make specific reference to known hazards, such as soft verges in this case.
- Liaise with local councils as appropriate to see if improvements can be made.
- Remind drivers of the need to drive to the road and weather conditions and wear their seatbelt...This helped avoid serious injuries in this incident.

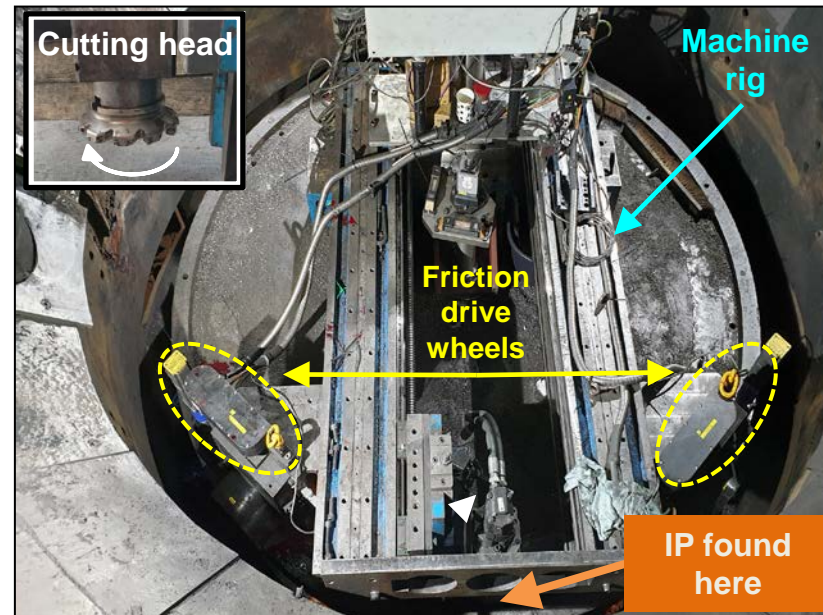
A specialist contracting company was carrying out work to machine a 2.9 diameter fuel mill table in situ. The engineering approach was agreed with CEMEX Europe Maintenance Team and the Original Equipment Manufacturer. Machining in situ is inherently less risky, negating the need to remove the 11 tonne table. To remove the table requires altering the fuel mill casing which is a pressure vessel and explosion rated.

The contract company is an expert machining company with 70 years heritage & a global leader for on-site machining. Both contractor engineers were in the fuel mill at the time of the incident as the equipment requires local setup and operation (by design). Under normal operation, the machine rig moves around the circumference of the 2.9 meter diameter table at extremely slow speed (1 revolution every 45 minutes), machining the surface to incredibly tight tolerances. The fuel mill was fully isolated and both contractors had their personal locks on the correct isolation point. The contractor engineers decided not to follow the design principles for the equipment and they increased the size of the cutter head and kept the machine arm stationary whilst adjusting the position. Due to these decisions, whilst starting the next phase of the cutting, the cutter head dug into the fuel mill table, which caused the whole machine rig to unexpectedly move at a higher speed than the operating speed. The injured person was hit by the machine rig causing a fractured leg and lacerations.

- Thorough induction completed prior to work commencing. Engineers were operating under a Permit To Work with Risk Assessment, Method Statement & WorkSafe. Fuel mill isolated correctly, and personal locks applied. No PPE issues. Avetta approved company, highly certified & expert in their field. Major overhaul planned and executed according to CDM Regulations 2015.
- The deviation from the complex operating procedure by the experienced and trained engineers could not have reasonably been anticipated or verified by the CEMEX supervisor for this extremely specialised task.
- CEMEX supervisor witnessed the incident and activated the site emergency protocols. CEMEX First Aid Responders provided invaluable medical support to the injured person, which has no doubt given him the best opportunity to make a full recovery. Site response team praised by the emergency services

Whilst the investigation concluded that the engineers deviation from the equipment design principles, this could not have reasonably been anticipated or verified by the CEMEX supervisor for this extremely specialised task. However, this incident is a reminder to **never deviate from the Standard Operating Procedures without assessing the implications by way of revised risk assessment. Always STOP and THINK!**

- Always follow Standard Operating Procedures. If something does change, stop, review the working method and carry out a revised risk assessment. If in doubt, ask!
- Ensure emergency preparedness plans are up to date and regular drills are carried out.
