SAFETY ALERT

HiPo – BITUMEN PUMP GASKET FAILURE

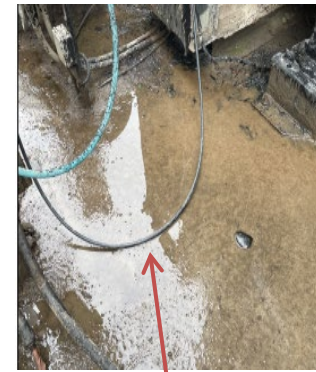
Pipework	The pipes connected to the pump were installed at an angle, which likely complicated the installation of the sealing gaskets during the pump's fitting. Additionally, the pump flange was square while the pipe flange was round, and a portion of the flange had been removed to accommodate the bolts on the side where the failure occurred.
Gasket	The gasket appeared to have been 'pinched' during installation, resulting in a vulnerable area that permitted the gasket to split.
Inspection & Maintenance	The piping and pump have been installed for several years without any problems or indications of malfunction
Air system	The cables and air pipes were raised, apart from one pipe positioned at ground level. This pipe ruptured when it became enveloped in bitumen, resulting in a spray of hot bitumen at an approximate temperature of 135-140 degrees being projected upwards.

Failed gasket

- Assessing the existing condition of equipment, ensuring components are compatible, standardisation of equipment where practical, considering the consequences if a failure was to occur.

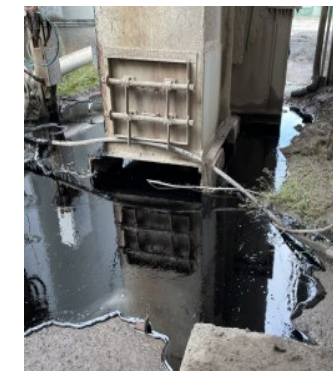
A rupture in the air pipe caused bitumen to spray upward.

- Review bitumen systems to determine if there are water or air pipes situated at ground level that may come into contact with bitumen in the event of a spillage from any section of the system.
- Is the bitumen pump adequately shielded to prevent the outward spraying of bitumen?
- Are all flanges enclosed to prevent bitumen spray in the event of a seal failure?
- Are relevant inspections in place for bitumen systems?
- Are there signs of leaking from pipework?
- It is essential to promptly address and repair any leaking bitumen pipework.
