SAFETY ALERT

CONTRACTOR HAND INJURY

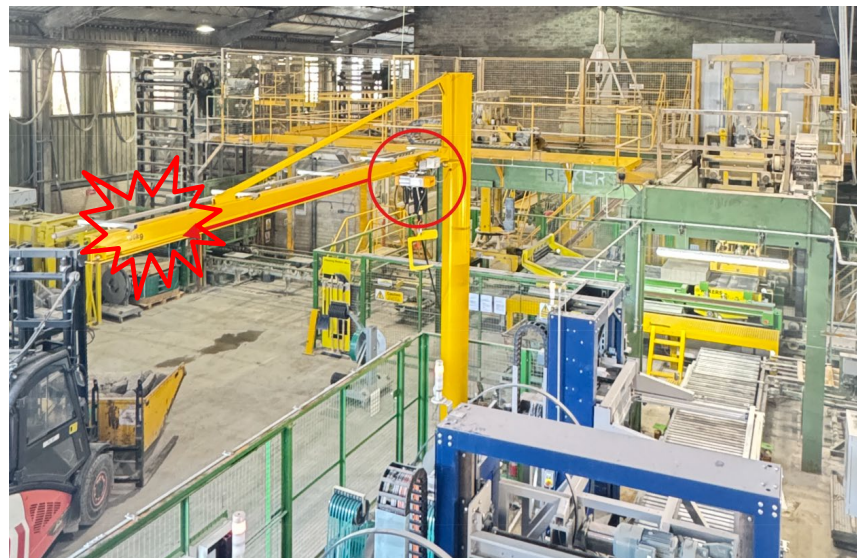
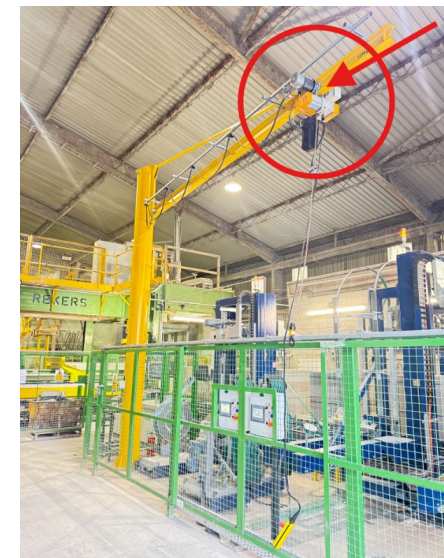
As part of the commissioning of the jib crane, two Service Engineers were carrying out deflection tests, an activity which involves putting a weight on the lifting hook and travelling the trolley across the runway beam. One Engineer was at height in a mobile elevated work platform inspecting the beam, while the other Engineer controlled the movement of the trolley via a pendant control at ground level. As the Engineer at ground level operated the trolley to travel slowly across the beam, the Engineer inspecting the runway beam had hold of the beam, with his hand too close to the trolley and the trolley trapped the end of his index finger. The resulting wound had to be closed with dissolving stitches.

PPE	The Injured was wearing the correct PPE including gloves.
Training	Both Service Engineers are competent and approved vendors; however, they are not assigned to MP Connect for individuals.
Compliance	A Permit to Work was issued and specific risk assessment and method statement (RAMS) completed.
Risk Assessment	RAMS did not identify risk of hands being 'in the line of fire' or highlight the need for effective communication.
Supervision	Ensure periodic supervision checks are carried out on Contractors.

- Encourage contractors to adopt a STOP & THINK mentality by carrying out pre job risk assessments before tasks commence and again if there is a change in working method.
- Ensure risk assessments and method statements consider key activities where coordination and communication needs to be clear; both Engineers should have communicated with each other before operating the crane to ensure they were clear before carrying out the deflection test.
- Ensure we STEP IN / Take 5 Together if we see anyone who may be at risk of injury.

- Do the RAMS/SSoW detail how of to carry out commissioning procedures. In this case, the procedure of how to carry out a deflection test in detail.
- Do contractors need 2-way portable radios when carrying out tasks at different height levels.
- Ensure pre job risk assessments are carried out (e.g. Take 5) before tasks start to ensure all hazards and risks have been identified and necessary precautions are in place.
