UK SA10/2025 – 09.10.2025

# SAFETY ALERT

## MTC - CONTRACTOR THUMB TIP FRACTURE

Lifting hoist:  
PHT Climafuel Pfister

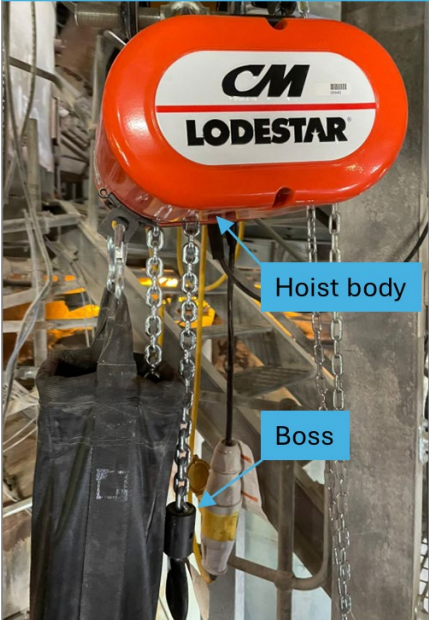
A contributing factor to the incident was the design of the lifting beam and hoist setup. Due to space constraints caused by surrounding equipment, the chain lift point cannot be centrally aligned with the trap door, requiring the IP to manually guide the load into position. Additionally, the hoist was mounted at head height (again due to space constraints), creating an accessible nip point between the hook and the casing.

Photo showing the relative height of the beam – space is very restricted in the area!

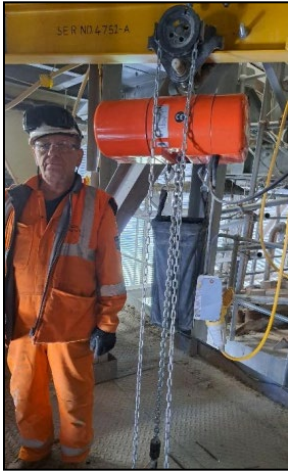
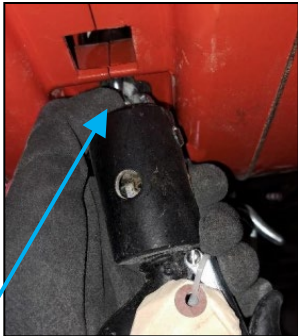
The injury occurred when the injured person (IP) attempted to manually guide the load by holding the hook during hoisting. A moments loss of concentration resulted in the IP’s left thumb becoming trapped.

The boss shown in its upper trip position between the shoulders of the casing. The illustration shows how, despite the ‘safety gap’, the thumb can still be nipped (see blue arrow opposite)
