UK SA09/2025 – 09.10.2025

# SAFETY ALERT

## EMPLOYEE MINOR ANKLE FRACTURE

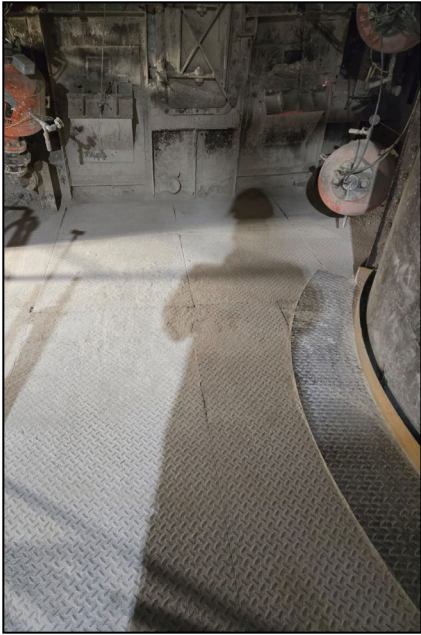
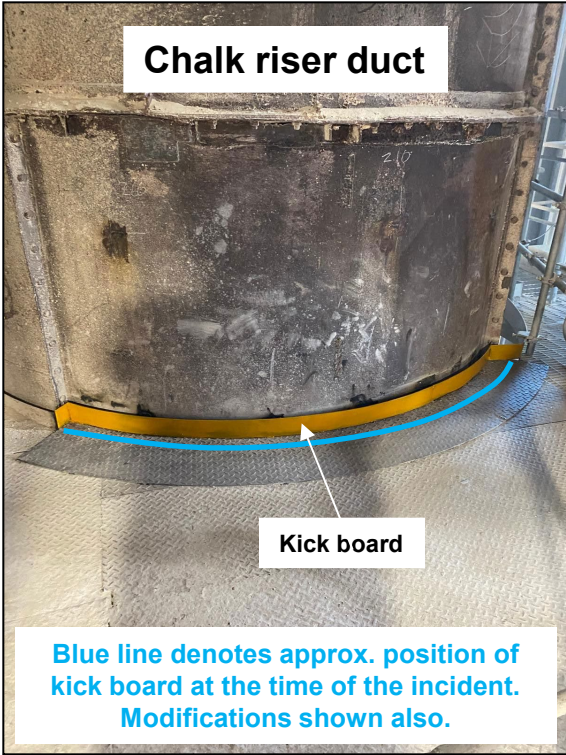
During routine water jetting in the pre-heater tower (PHT), an employee mis-stepped while moving backwards during water jetting, causing his right foot to step into the gap beyond the walkway kickboard. This led him to momentarily lose balance and roll his left ankle. The gap, located between the walkway and the chalk riser duct, measured 18cm and was obviously never large enough for a person to fall through.

The restricted space on the working platform, a result of the PHT’s design (including the routing of ducts), is a contributing factor. To improve the area, the kick board has been moved slightly closer to the duct – see below. Note: the gap cannot be closed completely, and therefore the kick board must remain in order to allow for thermal expansion – the duct runs hot due to process conditions.

Blue line denotes approx. position of kick board at the time of the incident. Modifications shown also.

Water jetting is an activity that does require the operator to step backwards. Where feasible, ensure the area behind is of sufficient space and free of any structures.
