# SAFETY ALERT

## EMPLOYEE ANKLE INJURY

UK SA12/2025– 27.11.2025

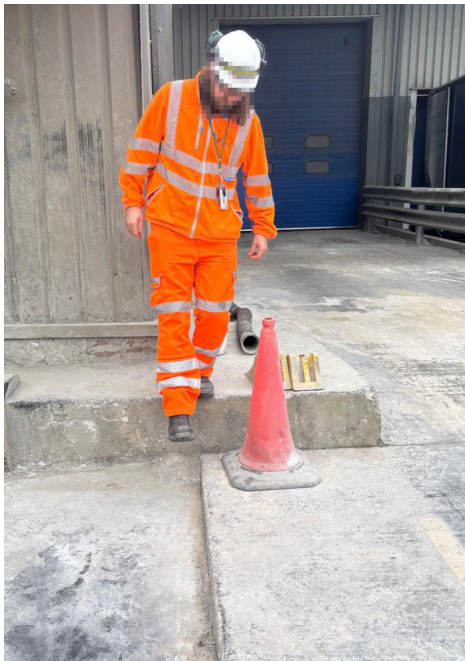
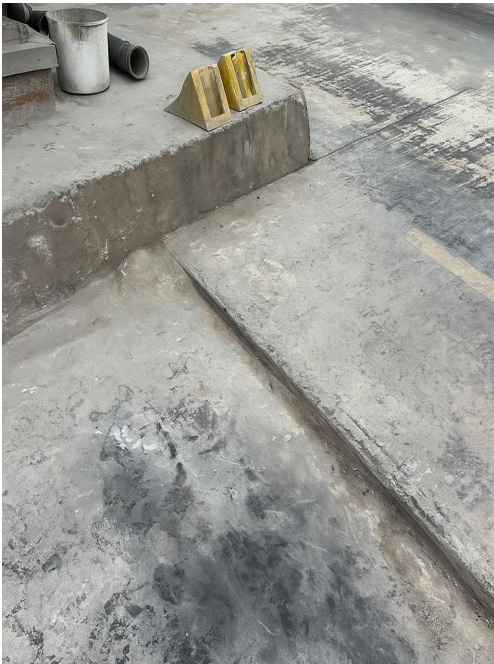
To access the silo inlet pipe, the driver was required to step up onto a curb located at the base of the silo. While stepping down from the raised curb onto an adjacent concrete slab, his right foot landed on an uneven expansion joint between the two slabs. The level difference was estimated to be between 40–50 mm. As a result, his ankle twisted, causing him to lose balance and fall to the ground.

Take 5	A Take 5 had been completed by the driver, but the differing height level of the expansion gap was not identified.
Competency	The driver has been employed by Cemex for three years. He is fully trained and experienced in his role. His training records are up to date including driving and tanker assessments, with no issues identified.
PPE	Full PPE was worn with ankle protection boots and laces which were tied correctly
Workplace layout/Design	The expansion gap height difference wasn’t identified as a hazard and accepted as part of the normal workplace environment. The customer has now highlighted the uneven area with yellow paint to emphasise the height difference.

- Conduct routine inspections of all work areas, including walkways, to identify any uneven surfaces or variations in elevation.
- Ensure that all uneven surfaces, such as expansion joints, are clearly marked to facilitate the identification of potential hazards
