INCIDENT DETAILS

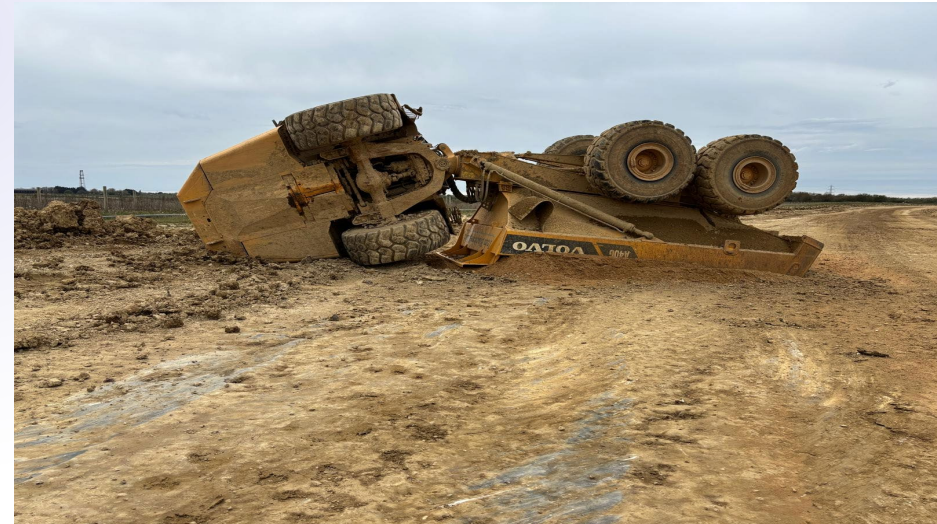
A contractor was operating a Volvo A40 articulated dumper, moving material from the excavation area to the processing facility. While turning a corner on the haul road, the vehicle began to skid on the wet surface caused by dust suppression. The driver applied the brakes, which caused the vehicle to slide further. When the vehicle reached a dry section of the road, it overturned. The operator refused to undertake a post-incident drugs and alcohol test and was subsequently removed from the site.

| ✓ | The vehicle was being operated on a flat clay road that had been recently watered for dust suppression. |
| ✗ | Excessive speed was a contributing factor to the rollover. |

- Review of site speed signage.
- Ensure all operators drive to the conditions and adhere to site speed limits.
- Ensure drug and alcohol testing is in line with company procedures including testing of new starters and contractors, with cause and post incident testing.
- TAKE 5 to risk assess changes to driving conditions
