INCIDENT DETAILS

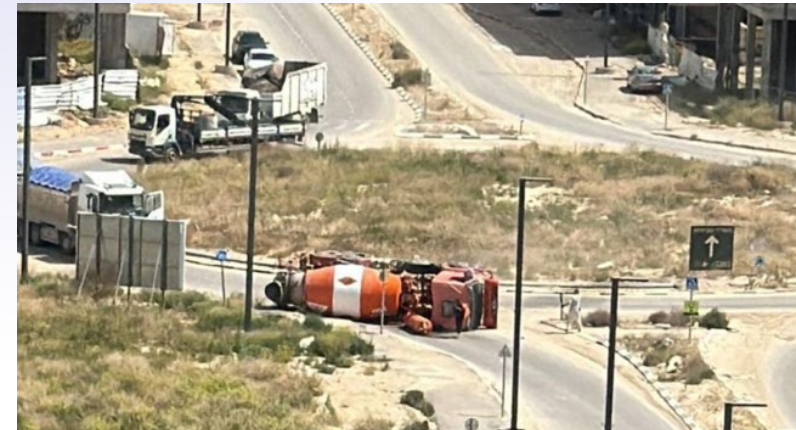
On the way to a nearby customer site, a contracted readymix truck entered a roundabout. While navigating the turn, the truck lost stability and rolled over onto its side. Fortunately, the driver sustained only minor bruises.

| ✗ | Speed: According to GPS data, the contracted driver entered the roundabout at approximately 22 km/h. |
| ✗ | Drum rotation: According to the driver, a high drum rotation speed was used due to the short distance to the customer site, to keep the concrete ready. This may have contributed to vehicle instability during the turn. |

- Ensure all drivers are clearly instructed and monitored to reduce speed when approaching and navigating roundabouts and turns.
- Verify and enforce that drum rotation speeds are kept within safe limits during travel (not more than 3 RPM).
- Clarify that when the customer site is close, high drum rotation (mixing speed) should be carried out at the plant or upon arrival at the customer site – not during travel on the road.
