INCIDENT DETAILS

KEY FINDINGS

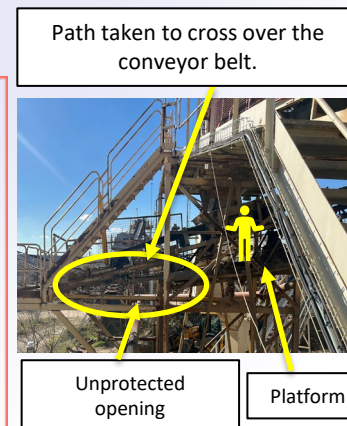
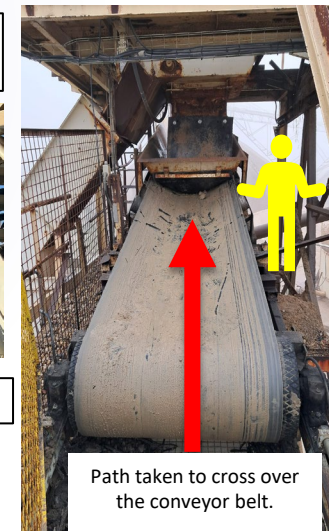
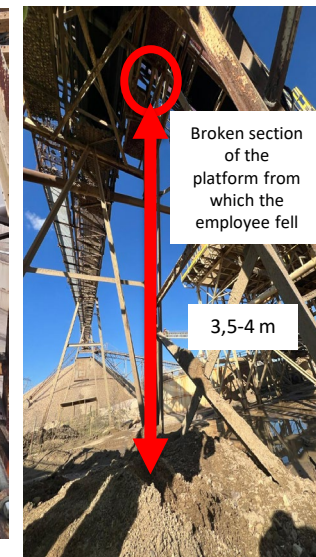
Two employees were carrying out measurements on the skirts of a conveyor belt. To access the right side, one of them removed the guarding and climbed onto the belt, which had previously been isolated, and accessed a platform located on that side. The platform, which was next to an unprotected opening, was covered with accumulated material and the employee partially cleared it before standing on it. At that moment, the platform gave way, and the employee fell 4m but was cushioned by accumulated material on the ground. Thankfully, only minor injuries were sustained.

- ✗ Lack of job-specific planning, including no safe method of work in place and hierarchy of control not fully considered i.e. eliminating working at height
- ✗ No permit to work issued. Informal discussion held between the supervisor and workers in the site office
- ✗ High risk tolerance. Employees were aware of the risks and the harness requirement but not followed. Take 5 was not carried out.
- ✗ The co-worker did not alert his colleague of the risk
- ✗ The platform was not a working platform and did not have proper weightbearing capacity

- Risk assessments are in place, and controls follow the ERICP hierarchy
- Working at height controls are followed, including harnesses, correct anchor points etc
- Take 5 requirements are known by all site personnel
- 'Alert Me'/'Step In' culture is promoted
- Structural surveys are conducted by competent persons according to local requirements
- Effective housekeeping and material spillage prevention regimes in place
- Infrequent working areas are still subject to inspections, visits etc
