#### INCIDENT DETAILS

In the workshop, a section/flange of an armoured pipe [compound material of normal steel (outside) and of wear-resistant steel (inside), with a diameter of 150 mm] needed to be cut. To do this, the pipe section was placed on a roller stand. In a first step, one employee cut all the way around the pipe (from above, the upper 180 °). He just cut the layer of normal steel, assuming that the wear-resistant steel inside still has sufficient contact with the flange. Then they wanted to rotate the pipe (including the flange) by 180° for the final cut. But as the connection between the normal steel and the inner wear-resistant steel was defective, a full compound of the two layers was compromised, and hence the flange unexpectedly detached, before the pipe could be rotated, and fell onto the finger of a second employee. This resulted in a fracture of the first limb of the ring finger of the second colleague.

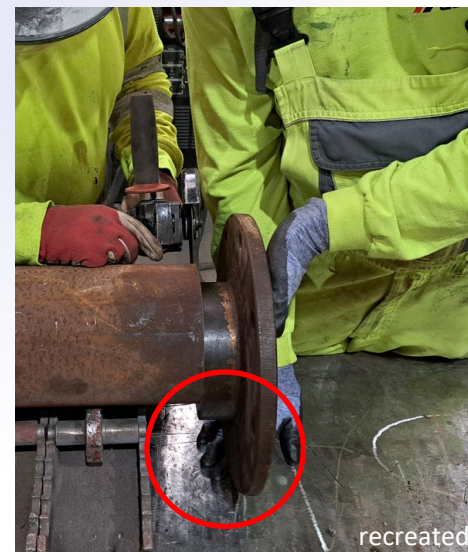
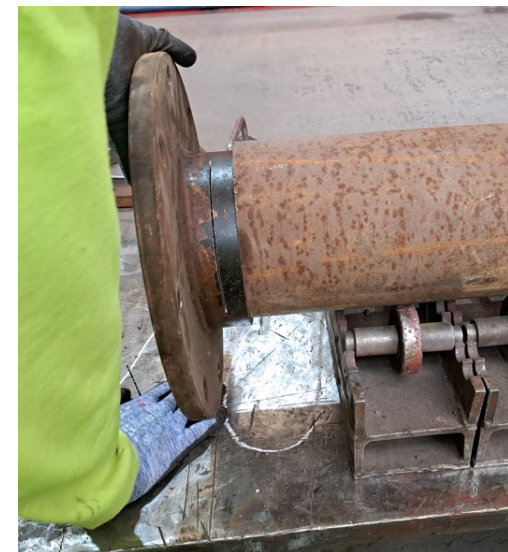
| ✗ | Although an on-site safety check (Take 5) was carried out, it failed to take into consideration the risk of the materials not bonding properly any longer and, consequently, the flange falling unexpectedly. |
| ✗ | The joint/compound in the armoured material was faulty |
| ✗ | Failure to secure the section/flange to prevent it from falling |
| ✗ | Use of normal gloves (w/o protectors) |

- When planning the work, take measures to secure the part to be cut
- Carry out a full Take 5, with consideration of all possible risks
- Do not put yourself into the line of fire
- Make use of the available safer gloves with protectors
