## INCIDENT DETAILS

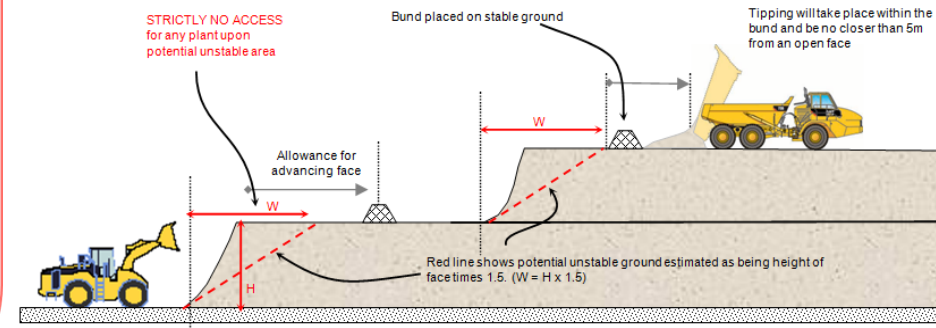
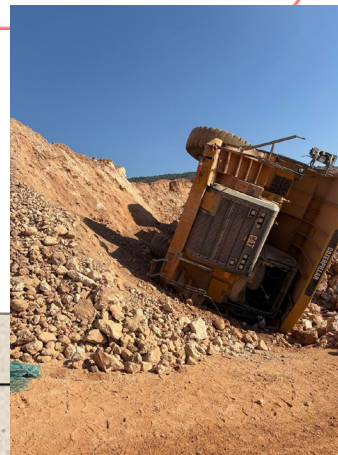
During the first unloading of the day, a 775 haul truck was unloading material at a stockpile when it overturned onto its left side during the dumping process. The preliminary investigation found that the edge protection failed to prevent the truck from reaching the edge. Fortunately, the driver was not injured.

| ✗ | The edge protection was ineffective due to deterioration and it's proximity to the edge and as a result, did not provide the required protection at the tipping edge. |
| ✗ | The condition of the stockpile tipping area and the edge protection <b>were not adequately monitored and maintained</b> before unloading operations. The team did not consistently carry out the routine inspections of the work environment. |
| ✗ | Critical controls for safe unloading at the stockpile were not fully implemented |

- A competent person should be appointed to inspect stockpiles and tipping areas before vehicles work on them, and ensure that the bunds structure, strength and location are correct.
- Reinforce pre-use inspections of unloading areas and require operators to stop work and report any unsafe conditions before tipping .
