CUTTING DISC FAILURE

Details of Incident

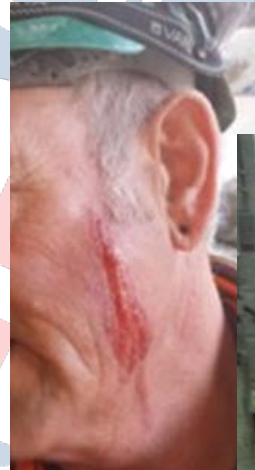
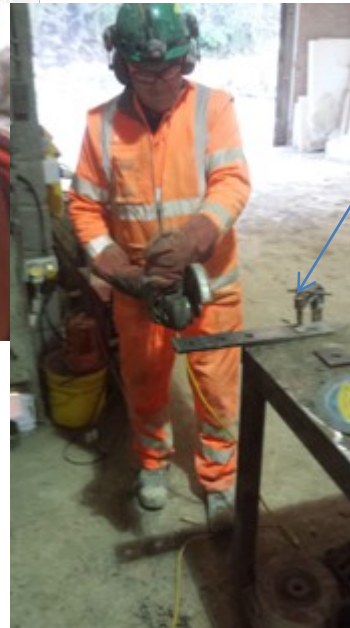
Task being undertaken

An employee was very fortunate not to have been more seriously injured whilst cutting some steel, when a 230mm cutting disc being used in a hand held grinder broke away from its centre hub. The disc struck the employee's cheek at high speed, causing cuts and grazes to his face.

- The disc was not purchased by the site, it had been obtained via a contractor. It was only 1.9mm thick and had exceeded the manufacturers warranty expiry date
- The employee was wearing safety goggles, but not a full face visor
- He had received training in the use of abrasive wheels and the work piece was securely clamped

- Arrange for the steel to be pre cut off site
- Use an alternative / better method of cutting
- Ensure discs are in good order, know how they have been used / stored and their expiration date
- Check discs thoroughly for defects before use
- Ensure the rpm rating of the disc is not exceeded
- Avoid the use of 1.9mm thickness discs
- Use cutting discs with great care; the force applied should be minimal and from directly above the cut being made
- Wear a full face visor and goggles

- Ensure Safe Systems of Work are in place for the use of hand held grinders
- Limit their use to authorised / competent personnel
- Purchase the right discs for the task and store them correctly
- Use the necessary PPE for the task, in this case goggles and a visor
