BURIED CABLE STRIKE

Details of Incident

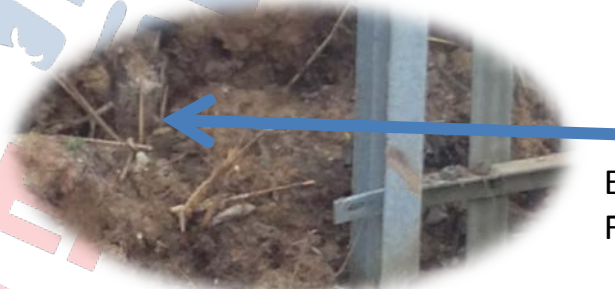
Existing Fenceline

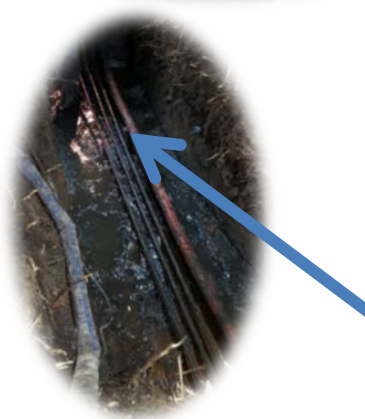
- The contractors were shown the line of the new fence by a Supervisor.
- A method of work had been agreed and Permit to Work and Worksafe completed.
- Unknown to the site staff, the contractor decided it would be easier to dig the holes further back from the original fence line, to avoid an existing tree route, which took them into a neighbouring property.
- The area they dug into had not been scanned because they were not supposed to be digging there.

Auger struck here

- The contractors should have followed the instruction in the Permit to Work and method statement, digging in the prescribed locations.
- Scanning of the adjacent land and access to the site plans of the neighbouring property may have increased awareness of the dangers of not following the agreed procedure.

- Ensure contractors understand that deviation from agreed Permits and methods of work is forbidden without prior approval from an authorised company Supervisor.
- Provide sufficient Supervision of contractors during these sort of tasks.
- Prior to excavating on site boundaries, consult neighbours in respect of buried service plans and scan for cables as appropriate.
