# UK SAFETY ALERT

SA07/2017 – 20.02.17

## EMPLOYEE LTI – SLIP / TRIP / FALL

## FALL FROM LOADING SHOVEL

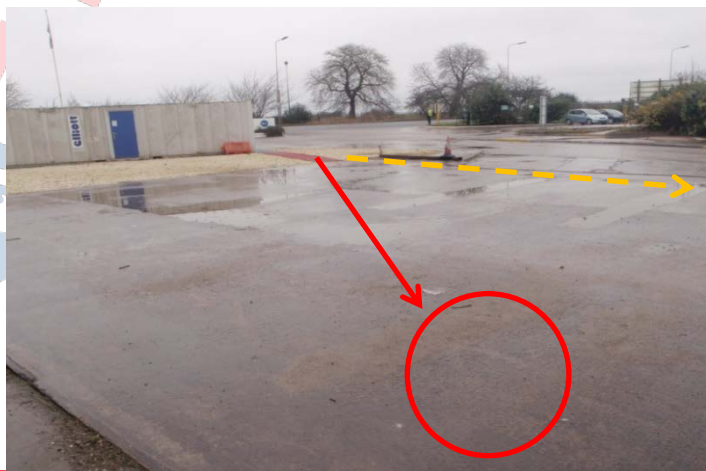
A Process Operator was entering the plant at the start of the shift at 05.00 am. It had been raining for most of the night and air temperature was 2 - 3 Centigrade. He followed the designated PPE free walkway from the car park to the temporary sign in cabin. He then cut across the old office block area and slipped on a patch of ice falling backwards onto his wrists and back, received a graze to his finger and a bump to the back of his head. He reported the incident and after an initial check by a first aider returned to work. Shortly afterwards he reported feeling unwell. He was taken to hospital where a doctor diagnosed possible concussion and advised to rest for 48 hours.

- The Operator deviated from the designated route.
- The route taken had a good surface
- The fall area was in the shade of the silos and ice patches remained from the previous days frost.
- Lighting in the area was poor and he was walking towards a brightly lit area.
- The PPE free designated walkway passes through unbarriered PPE specified areas.

- Designated walkways should be clearly defined and enforced.
- PPE zones should start close to the front of the plant
- Light in the area should be adequate for the task.
- Colleagues may have had an opportunity to Step In and highlight the risk of injury of using the short cut

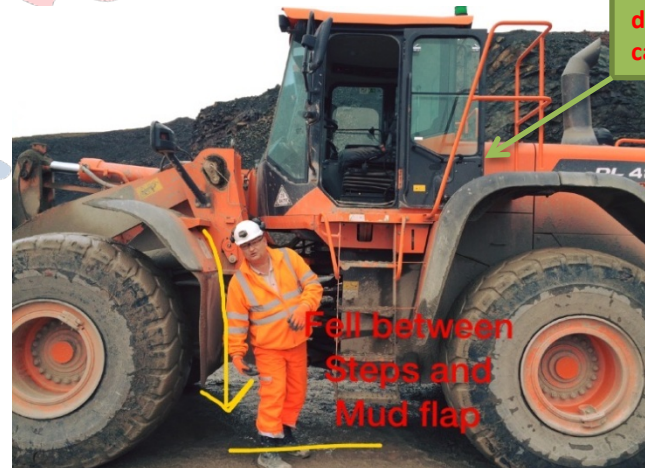
- The loading shovel was an older design and didn't incorporate the very latest safety features to minimise the risk of falls.
- The door catch, which holds the door in the open position, was broken and allowed the door to swing towards the Operator.
- The broken catch was verbally reported as a defect but had not been recorded in the daily inspection book; the necessary parts were however on order.
- The injured person had momentarily forgotten that the catch was broken and the door was not secure.

Broken  
door hold  
catch

Fell between  
Steps and  
Mud flap

- Use of machines that incorporate features aligned to the industry "Safer by Design" principles.
- Prompt rectification of the door catch.
- Use of a written prioritised defect reporting procedure.
- Care and attention being taken at all times.

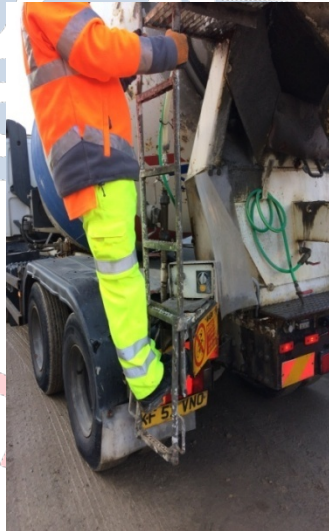
After discharging concrete at a customer site, a truckmixer driver started to climb his ladder so he could wash down the chutes; however the driver lost concentration and missed his handhold. As a result he fell backwards and struck a mobile compressor (parked next to his truck) before reaching the ground. The compressor engine lid was closed but not secured, leaving the hook side of the catch exposed. The driver unfortunately scrapped against the exposed hook, which grazed his backside. The driver finished his duties on site and returned to the supplying plant, he was then taken to the local hospital where his wound was cleaned and dressed.

- The driver had recently undergone the new IHC induction.
- The driver was wearing the correct PPE with gloves and boots in good condition.
- Truck was in good order with all safety features fitted and working.
- While the site was muddy, the incident wasn't related to a slip and there was a good level of grip provided by the rungs of the ladder.
- At the point of falling off, the driver had both feet on the same rung of the ladder. It is believed he slid both hands up the ladder at the same time to continue climbing, therefore removing 3 points of contact and causing him to fall backwards when he missed his grip.
- Poor positioning of compressor wasn't identified as a potential hazard (My Space).

- By carrying out an effective MY Space assessment
- Ensuring three points of contact on the ladder
