# UK SAFETY ALERT

UK SA10/2020 – 05.10.2020

## HIPO – DRIVER PUTS HIMSELF AT RISK WHILST WORKING ALONE

## PLANT OPERATOR TRAPS HAND IN WEIGHTED SWINGING GATE

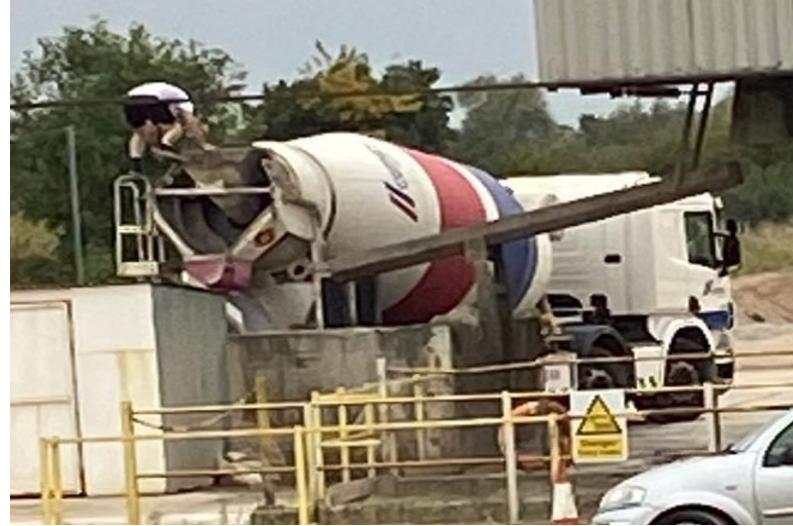
Returning to site from a vehicle maintenance workshop repair, a RMX truck mixer driver heard noises coming from inside the mixer drum. Working alone on site, he reversed the vehicle into the wash out bay to discharge the object causing the noise.

He then proceeded to investigate further by attempting to access the drum via the fixed ladder platform, above the handrail and without wearing any protective clothing or equipment. Thankfully he wasn't injured; however, due to his risk taking behaviour, he is no longer working on behalf of the business.

- Driver returned to site after production hours.
- Driver worked alone.
- Driver did not wear PPE.
- Driver put himself at risk by working at height, unsupervised & without appropriate access equipment.
- STOP & THINK behaviour not used.
- Driver Induction training completed including CEMEX Safety Essentials & MYSPACE elements.
- Driver not aware of Site Lone Working Procedure

- Use of STOP & THINK approach
- Follow CEMEX Safety Lone Working Process
- Report defects to line manager
- Follow risk assessment principles

- Review Lone Working procedures, ensuring they are communicated & understood by drivers.
- Never work at height without adequate fall protection.
- Communicate all relevant rules & procedures

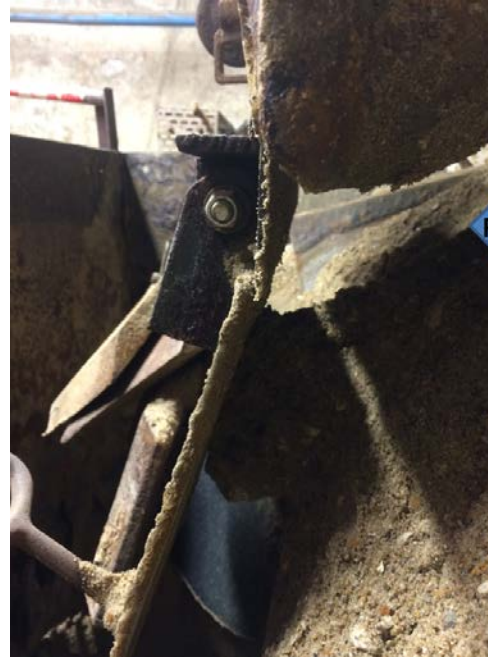
When investigating at the feeder, he believed material was caught behind a weighted swinging gate used to regulate the flow.

The Operative placed his hand on the gate to pull and release suspected material, when he released pressure, the gate swung shut trapping his index finger.

- There was no risk assessment or safe system of work for clearing the weighted swinging gate.
- There was no recognised method of clearing the gate.
- Although standard gloves were being worn, the Operator's hand was placed "in the line of fire".
- The Operator is a new starter (although experienced in the industry) and had not received training on operation of the feeder.
- The increased flow of material could have led to spillage downstream, which may have led to some haste.

- Ensure all employees, including new starters, receive sufficient training and are competent for the full range of tasks required.
- Ensure risk assessment and safe systems for tasks are in place and communicated to relevant persons.
- Ensure appropriate guarding of trapping points.
- Do not position yourself in the line of fire.
