# SAFETY ALERT

## LTI Central Europe Materials – Employee fell from height on the construction site

## Isolation Procedures

## APPLY LOTOTO PROCEDURES BEFORE ENTERING ENERGIZED AREA

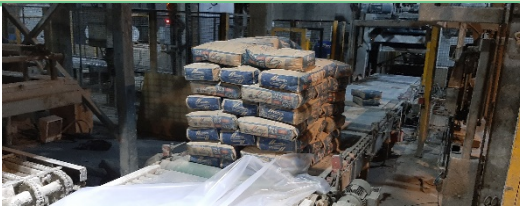
### Wrapping area

Two packaging operators detect that a bale (palletless) has not come out with all the bags correctly shaped. They apply the LOTOTO procedure in this area and enter to the interior of the facility and begin to rebuild the bale. While there, one of them observes that in the adjoining area, of the palletizer elevator, there is a bag of cement that covers the sensor preventing its operation. The worker walks on the conveyor belt, passes through a safety photoelectric barrier between the two sections to reach the elevator area and to remove the bag stuck on the sensor without applying the LOTOTO in this area. The worker, upon detecting that the elevator began to move, jumped quickly out but the elevator reached to catch the worker's right foot, causing a tear in the skin of the heel of the right leg

Apply the LOTOTO procedure before entering energized area

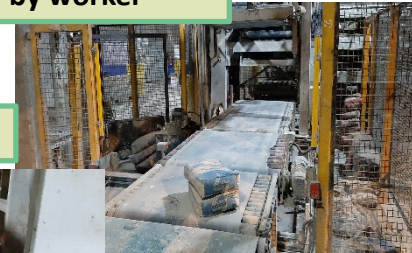
### Road to Paletizer used by worker

- Trained and experienced worker.
- LOTOTO applied in Wrapping Section.
- LOTOTO not applied in Paletizer Section, according to LOTOTO procedure.
- Photoelectrical safety barrier doesn't work properly.
