GLOBAL SAFETY ALERT

CONTRACTOR FATALLY INJURED IN ROLLOVER INCIDENT

SA 2022 / 3

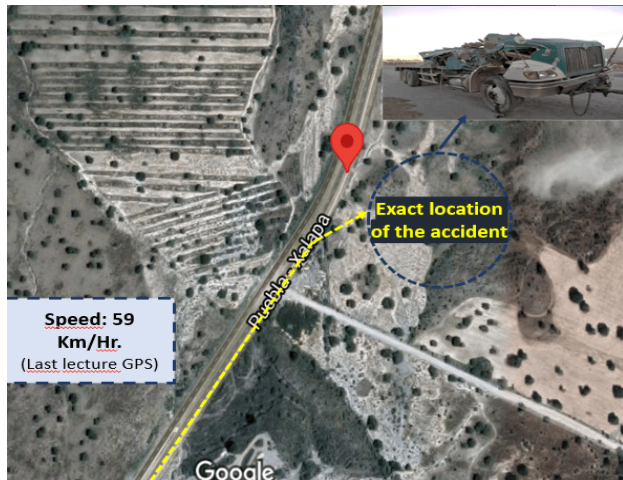
A contractor was driving on a highway at 59 km/h with 16 tons of bagged cement when he fell asleep and lost control of his truck on a curve in the road, causing it to overturn onto its right side.

Route of the truck
