Willington Quarry grading screen drive cover

William Newton | 2 Mar 2022 | ID225

Problem, context, environment, status

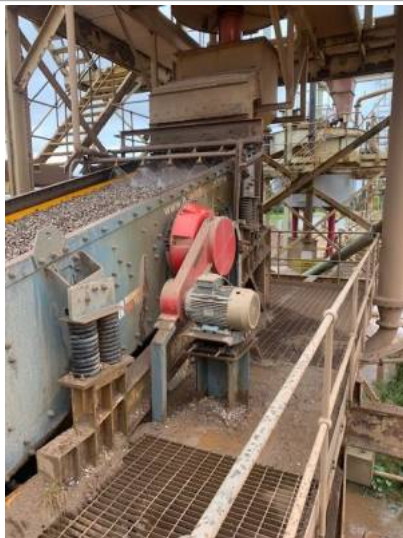
The site grading screen has twice over the last 12 months had a drive belt failure due to small amounts of spillage falling into the drive if the feed chute at the top of the plant blocks. This is due to small stones getting trapped in the drive and destroying the drive belt. This results in down time and loss of production so the spillage can be cleaned up and the drive belt replaced with new.

Grading screen drive

As it is very difficult to completely stop the chute above the screen from blocking, the best solution to prevent the down time of damage to the drive belts was to try and stop the spillage from getting into the drive and damaging the belts. This was done by fabricating a small cover above the drive to deflect spillage away from the drive belts, so preventing damage to the belts and increasing plant run time.

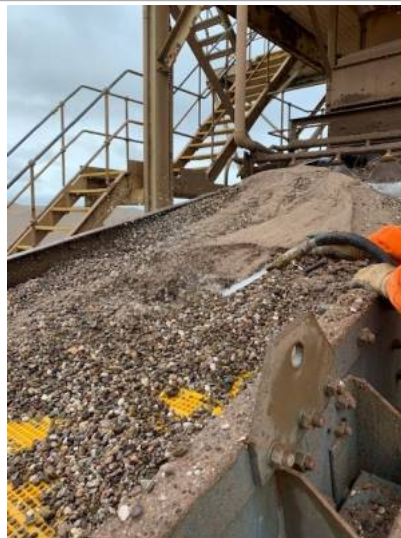
Blocked screen

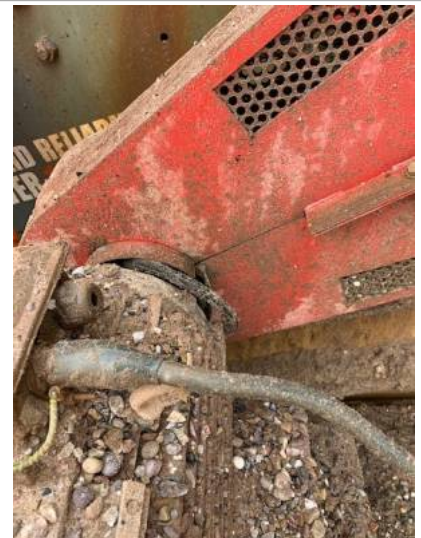
Spillage inside guarding

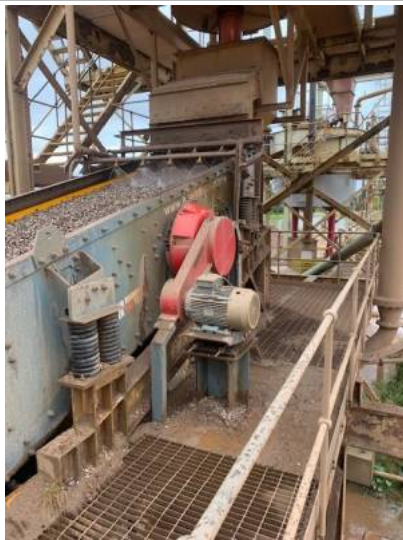
Screen with out cover

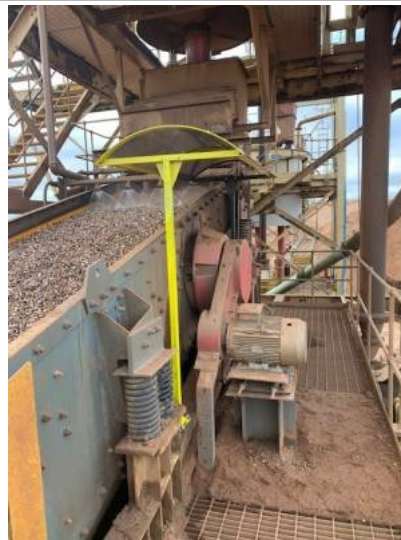
Cover fitted over drive

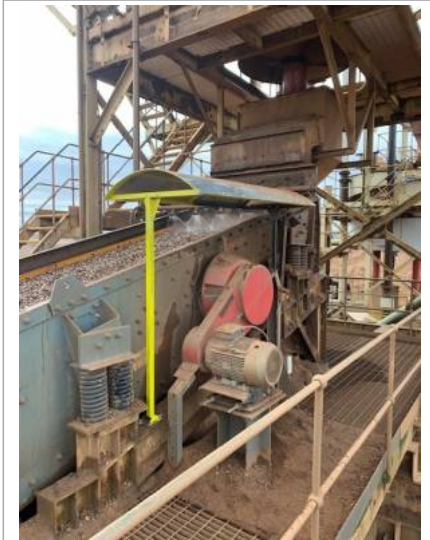
New cover

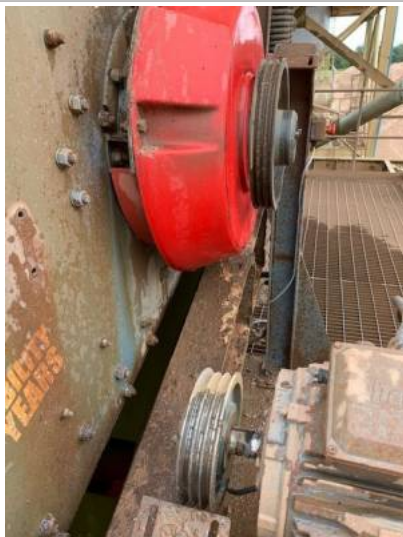
New drive belt

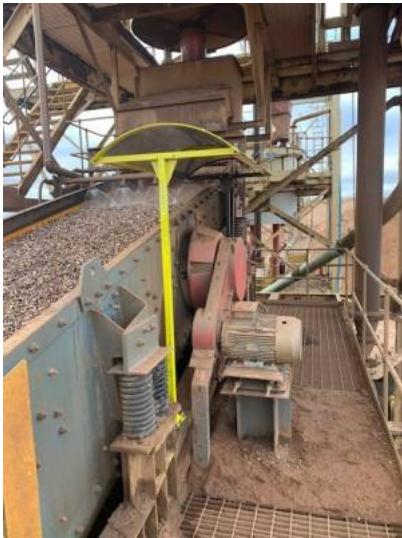
Cover

Reduce down time , reduce spillage from failed drive belts. Reduce cost by removing early failure of drive belts due to stones getting into drive and destroying belts. Easy to make and fit and effective , improving motor cooling by removing spillage that clogs motor fins.
