# Spillage from traverse feed hopper

Steve Batty | 16 Jan 2023 | ID328

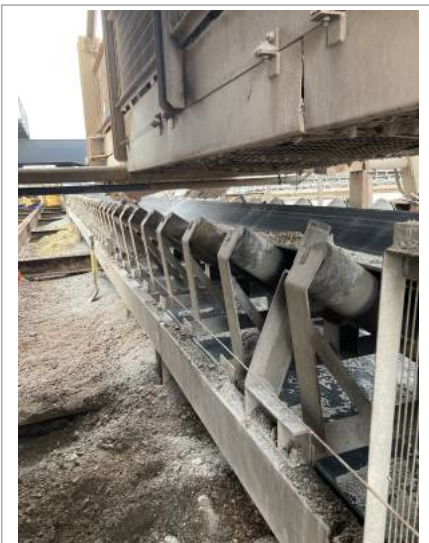
Spillage from jetty traverse feed hopper the full length of CV1 underneath. Also jamming up wing and return rollers as well as spilling on the return of CV1 jamming up tail drum.

The side skirt failed during ship discharge.

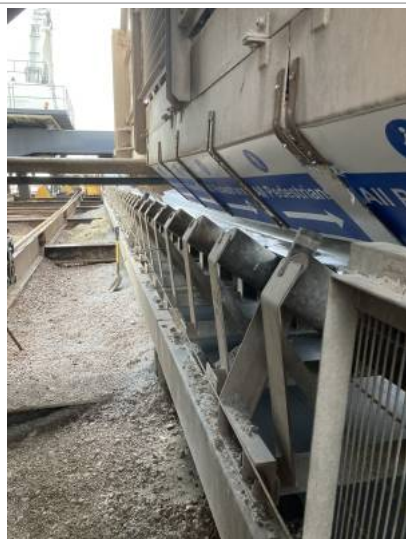
Deflector panels bolted onto under guards so what spillage does creep under the side skirt falls and gets deflected back on to CV1 underneath.
