GLOBAL SAFETY ALERT

EMPLOYEE FATALLY INJURED

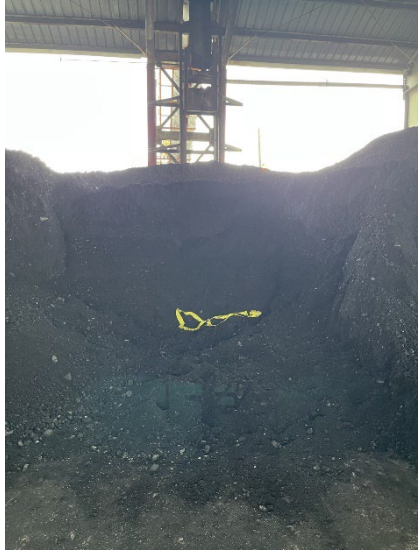
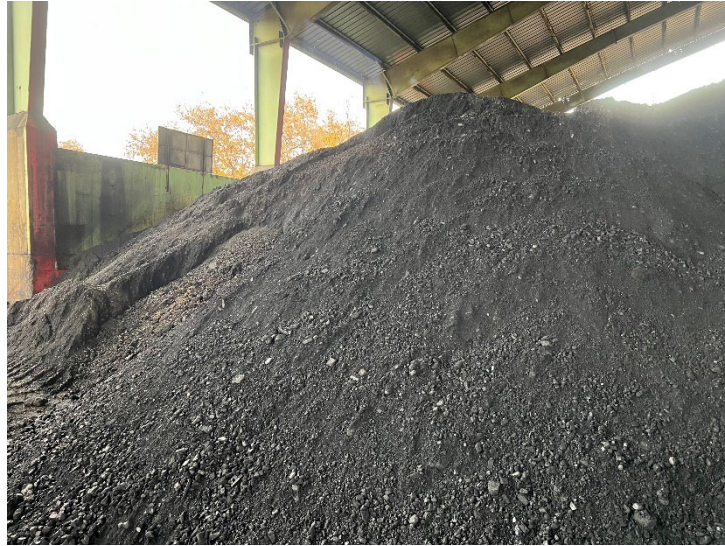
An employee was operating a front end loader in the coal shed. For unknown reasons he left the loader and became engulfed in the coal pile near the grizzly bar structure for the feeding system. County emergency services arrived and managed the recovery.

- The employee, who had approximately 1 year experience in the plant, was working on the night shift and was operating the front end loader to move coal onto the grizzly in the coal shed prior to the incident.
- There was significant inventory of coal in the storage building and limited separation between the stockpiles and the feed pile on the grizzly bar structure.

- Raw material and fuel stockpile storage areas are inspected regularly and controls in place to prevent pedestrian access to these areas. This should also include delivery drivers who may be present in these areas.
- Formal procedures have been developed for maintaining all material stockpiles at the angle of repose and controlling vertical faces that could slip away.
- That raw material and fuel stockpile storage areas have sufficient illumination and there are overhead visual markers to indicate the location of ground level grizzly feeders.
- Establish formal procedures when performing maintenance on feeding systems, that includes controls to isolate material stockpiles from the work area.

- Do not attempt to walk on any material stockpile, as these are inherently unstable.
- Never park mobile equipment or other vehicles near material stockpiles, as material can unexpectedly slip away.
