SAFETY ALERT

LTI – AGGREGATES – HIP CONTUSION

HIPO – TIPPER ROLLOVER IN QUARRY

HIPO – Alternative fuel tipper Rollover

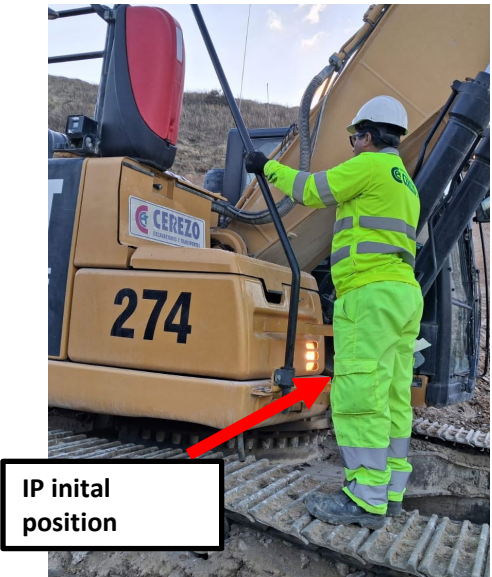
A contractor worker was standing on the track platform of an excavator, carrying out the usual checklist and level checks prior to the start of the working day. Upon finishing and making a body movement, one of his feet lost grip on the track surface (located approximately 85 cm above ground level) causing him to lose balance and fall to the ground. During the fall, the worker struck his hip. He was taken to a medical centre, where the relevant examinations were carried out. The specialist confirmed a hip contusion. Medical advice prescribed rest.

KEY FINDINGS	
✓	The worker had both feet on the track at the time of the incident.
✓	He was wearing all mandatory PPE, including safety boots with correctly fastened laces.
✓	The checklist and level checks were being carried out in accordance with the established daily procedure. This was the only available access point.
X	The task had not been assessed using the Take 5
X	The track surface may have been wet due to morning dew at the time of the incident (early morning), which likely contributed to the slip and loss of stability. This was not identified as a risk by the worker, possibly also due to insufficient lighting.

- HOW COULD THIS HAVE BEEN AVOIDED**
- Check the condition of access surfaces (tracks, steps, platforms) at the start of the working day, especially during cold, damp or icy conditions.
 - Assess whether the method for climbing, descending and checking levels can be reviewed to ensure these daily tasks are carried out safely and with stability.
 - Ensure that areas where checks are performed have sufficient lighting to detect hidden or poorly visible hazards.
- KEY REVIEW POINTS**
- Ensure workers always maintain three points of contact when on machinery.
 - Remind workers to take extra care during the early hours of the morning, when dew, frost or moisture can reduce grip when climbing on or off machinery or vehicles.

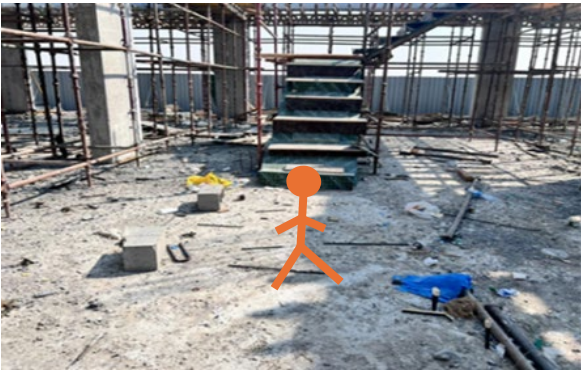
Injured helper position

At the customer site in Abu Dhabi, the pump helper tripped over his shoelaces and fell while carrying a water bottle. He did not report the incident that day because he felt fine and continued working. The following day, he experienced some pain in his left hand, so his supervisor sent him to the hospital for medical checks, and the hospital discharged him with a short arm splint applied to his forearm as a precaution for any minor, undetectable fissures (no fractures were found), then he back to his work.

✓ PPE	The pump helper was wearing the required PPEs.
✓ Take 5	He completed his Take 5 assessment and was trained in its use.
✓ Induction & Training	<ul style="list-style-type: none">He completed the site safety induction and mandatory training.He joined the “Tight Shoelaces” toolbox talk a few days before the incident.
✗ Behavior	He failed to tie his shoelaces correctly and didn't promptly notify the supervisor about the incident.

- All employees must always wear safety shoes with laces securely tied.
 - Remind employees to inspect and properly tie their shoelaces before commencing work and during scheduled breaks.
 - Conduct refresher training on workplace hazard identification, emphasizing slip, trip, and fall prevention measures.
- KEY REVIEW POINTS**
- Emphasize the importance of immediate reporting all hazards and incidents,
 - Regularly check footwear and PPEs condition to ensure compliance.

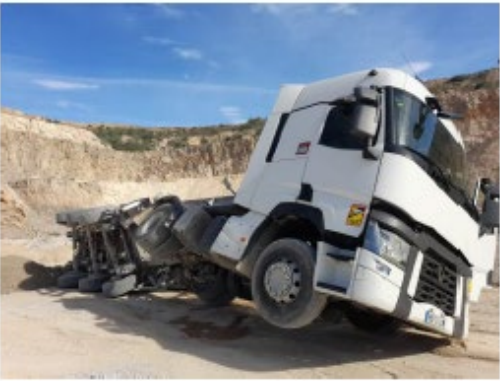
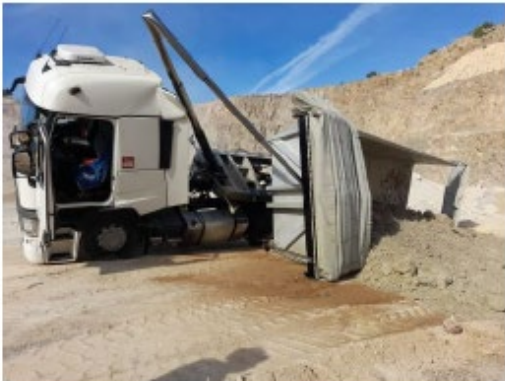
A subcontracted haulier transported concrete waste from the Cemex plant to the quarry for reprocessing. During unloading, the driver noticed an imbalance in the tipper body while tipping, which resulted in the body overturning. No personal injuries were reported.

✓	The driver was familiar with the route and the unloading area, and the tipper body was correctly aligned with the cab.
X	Unloading was carried out in an area with slight unevenness, despite the availability of nearby areas with more favourable ground conditions that had previously been used by other vehicles.
X	The truck and the driver were not validated on the contractor control platform, and there was no evidence of specific driver induction regarding rollover risks.
X	An uneven distribution of the load was observed during the rollover, with a higher accumulation of material close to the cab, generating an asymmetric load during lifting.
X	The material had a higher-than-usual moisture content and exceeded the maximum allowable capacity of the aluminum tipper body.

- Avoid loading materials with high moisture content that may increase adhesion to the tipper body and compromise unloading during tipping operations.
- Do not exceed the vehicle’s maximum allowable load and ensure correct and even distribution of the material in the tipper body.
- When transporting concrete waste, steel tipper bodies are recommended.

- During loading operations, site personnel and drivers must be aware of the type of material being loaded, the type of tipper body used, correct load distribution and the ground conditions at the unloading area.
- Drivers and vehicles must be authorized and validated on the contractor control platform.
- Confirm that heavy goods vehicle drivers have completed the required driver induction and are aware of rollover risks and the associated preventive measures.

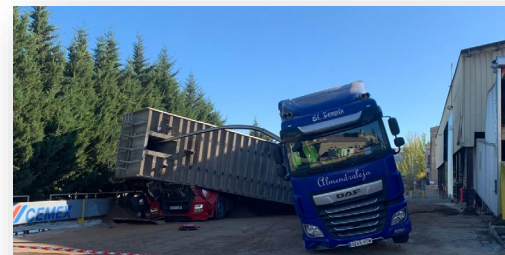
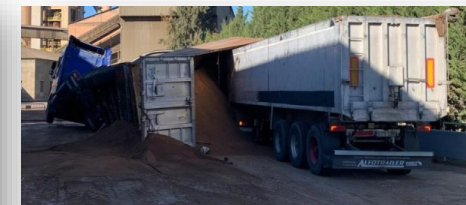
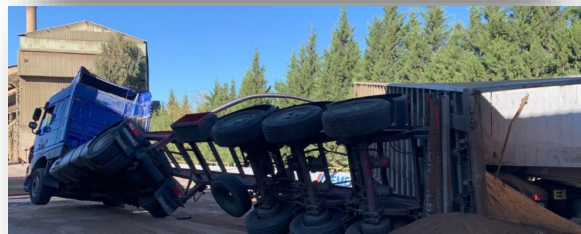
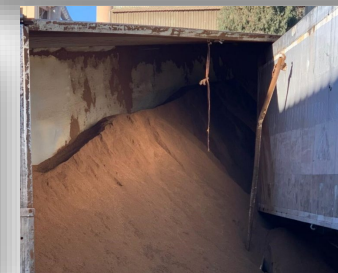
At the Alternative Fuels receiving area of a cement plant, two vehicles were positioned in parallel for unloading. One driver exited their cabin to assist the other, stepping outside the designated exclusion zone. During the unloading process, the trailer tipped to the right, impacting the adjacent vehicle's cab. No injuries occurred.

| ✗ | The material was loaded unevenly by the supplier and it was found to be stuck on one side of the trailer – it was loaded in rainy conditions and then parked up for 24 hours in cold temperatures |
| ✗ | The driver began discharging while another tipper truck was parked parallel, without respecting the 15-meter safety exclusion zone. |

- Effective systems are in place that ensures all truck Drivers receive a suitable and sufficient site induction
- Unloading areas are regularly monitored and checked
- Tipping procedures are up-to-date, known and enforced
- Ensure drivers can detect any issues during the unloading process, such as stuck material, that could lead to a potential rollover.
- Trucks are properly loaded by trained people
- **KEY REVIEW POINTS**
- Tipping does not take place on inclines, uneven, or soft ground.
- Exclusion zones (15M) and adequate signage in place.
- All drivers are informed, trained, and inducted on rollover prevention requirements and repeated periodically
- Consider alternative truck types e.g. 'walking floor trailers'

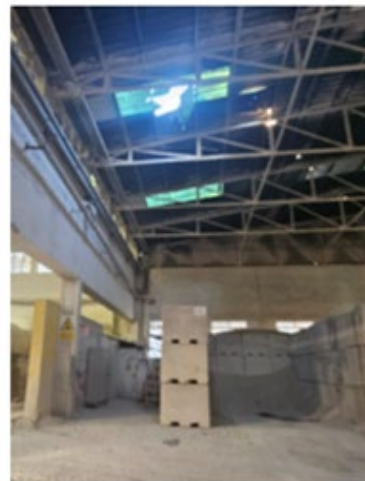
During lifting operations on the roof of the ready-mix plant, one of the pallets being lifted to be positioned on the roof became unstable. Part of the loaded material (aluminium profiles and technical sandwich panels being installed) fell through a nearby roof skylight, which was unable to withstand the impact and broke. Sections of the roof sheet and the falling material landed inside the plant, below the aggregates storage area. No workers were present below at the time of the incident. A concrete mixer truck was passing through the area, and some profiles struck the rear right mudguard of the vehicle.

| ✗ | The material on the pallets had been rearranged to reduce the weight of each pallet, but it was not properly secured or slung for lifting. |

- When carrying out tasks with a risk of falling objects, cordon off the affected area at ground level to prevent the presence of people in risk zones.

- The stacking of material on pallets must ensure that loads cannot move and that sling tension is minimised.
- Correct slinging of material loads is essential, and the type of slings used must be appropriate for both the load and the material.
- When working on roofs where there is a risk of falling objects affecting people below, consider installing safety nets or carrying out the work during periods with no plant activity.

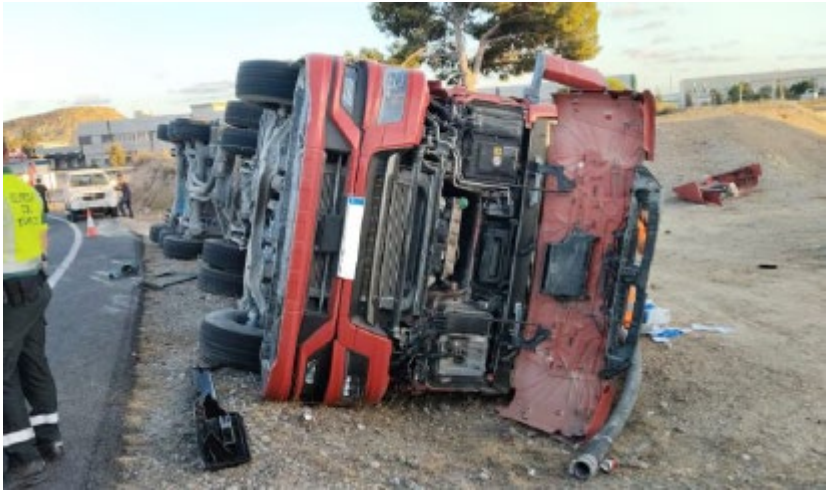
After completing work at the customer’s facilities and during the return journey, a contractor driver of a cement tanker truck suffered a rollover when entering a curve within the industrial estate where his base is located. The driver did not sustain any personal injuries.

✓	The driver was authorised as a contractor and had achieved a score of 8 in his latest driving performance statistics.
✓	Road and visibility conditions were good, with dry and clean ground.
✓	The driver had completed the daily inspection checklist and the “5 Steps” driver booklet.
✓	The driver was familiar with the route and the curve taken.
X	The investigation determined that the driver exceeded the speed limit for the curve (62 km/h), whereas the recommended speed for passenger vehicles is 40 km/h.

- Adapt speed to the actual road conditions (road surface condition, visibility, traffic, load being carried and vehicle type).
- Always drive in a fit and alert condition..

- Reinforce to all drivers the mandatory requirement to comply with speed limits, paying particular attention to curves and turning areas, where the risk of rollover in heavy goods vehicles increases significantly.
- Ensure ongoing training in defensive driving and promote immediate communication of any road condition that may increase risk and should be reported.
