SAFETY ALERT

Employee TRI – STF during a cleaning operation

HIPO – Tipper truck roll over while unloading aggregates on a readymix plant

Contractor TRI – Fall from truck ladder at a customer site

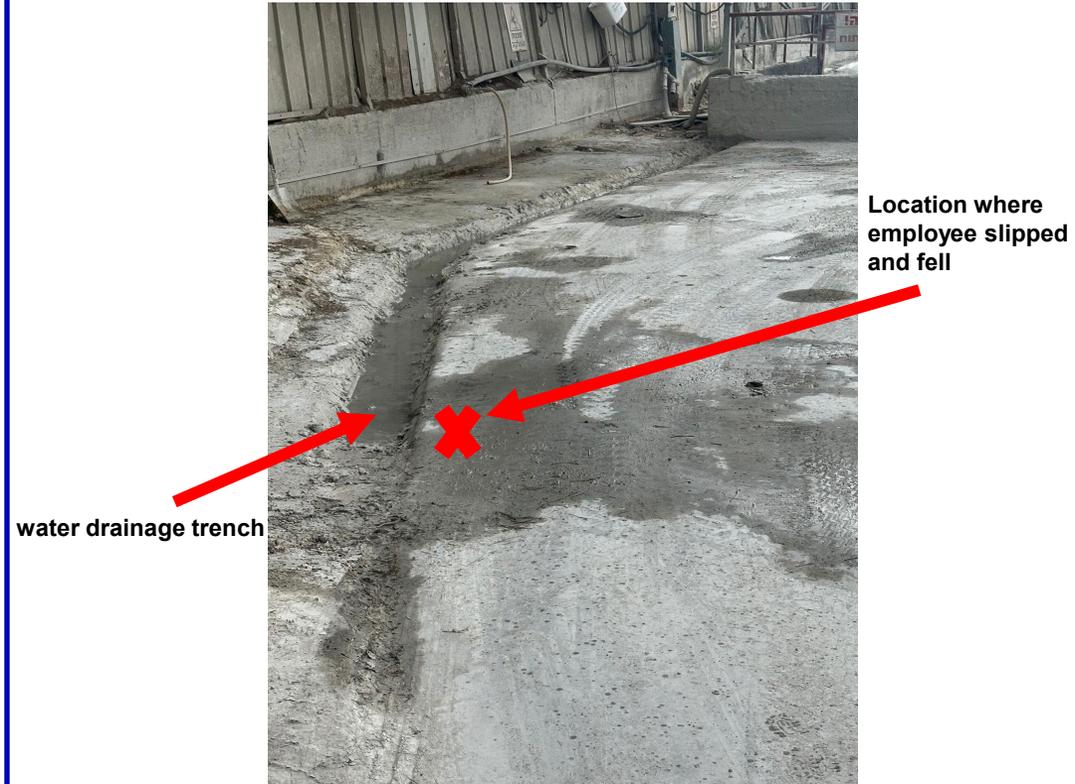
An employee was performing cleaning work using a Bobcat. Upon reaching a water drainage trench, the Bobcat could not access the area, so the employee proceeded with manual digging to clean the trench. During the activity, he slipped and fell onto his hand, resulting in a fracture.

✓	Employee received H&S induction and all required H&S training
✓	Employee used all required PPE including laced safety shoes
✓	Employee is experienced and is professional in using the bobcat for this routine cleaning activity
✗	Due to the rain and ongoing plant operations, the area was wet, containing water, mud, and cement residues that caused it to be slippery
✗	Employee did not perform Take 5 prior of the activity

- Take 5 – identify risks prior of performing the activity.
- Cleaning the area with bobcat before performing the manual work.
- Stay alert and adapt your actions to ground conditions

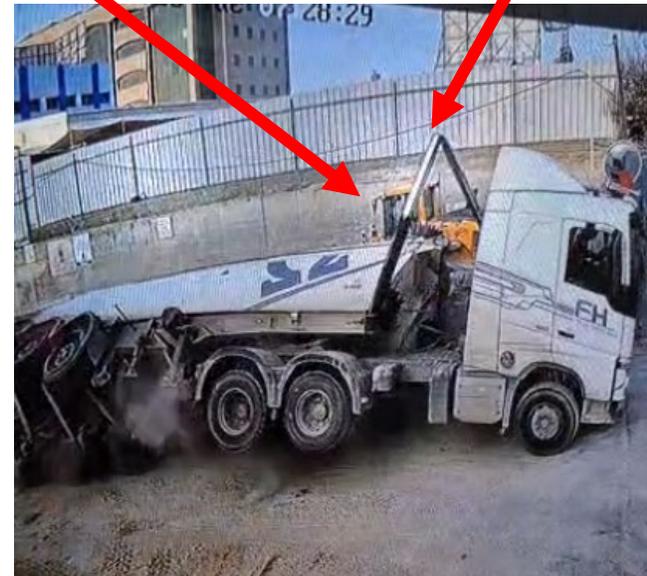
During its movement, a hydraulic cylinder failure caused the tipper truck body to tip sideways and overturn.

✓	The ground was level and free of materials. The truck was positioned on stable and even ground.
✗	After stepping outside the cabin contracted driver did not use the required PPE, loading shovel operator who was supposed to supervise the unloading did not intervene.
✓	Rear door was opened and the material was released during the unloading.
✓	Driver is familiar with unloading on this specific readymix plant and other CEMEX sites, 7 months of experience. Received general H&S induction.
✗	Driver did not stop the unloading upon identifying a malfunction of the third piston.
✗	Loading shovel parking was less than 15 meters from the unloading tipper truck.
✗	Mechanical failure of the truck's piston led to the roll over (probably a pre-existing mechanical issue in the truck led to the hydraulic cylinder failure).

Loading shovel parking location during the incident

Piston failure

- Maintain awareness of the truck's condition during unloading and stop immediately if something is wrong
- Maintain the truck in safe working condition.

- Maintain a minimum 15-meter exclusion zone during tipper truck unloading
- Contractor's management
- Maintain the truck in safe working condition

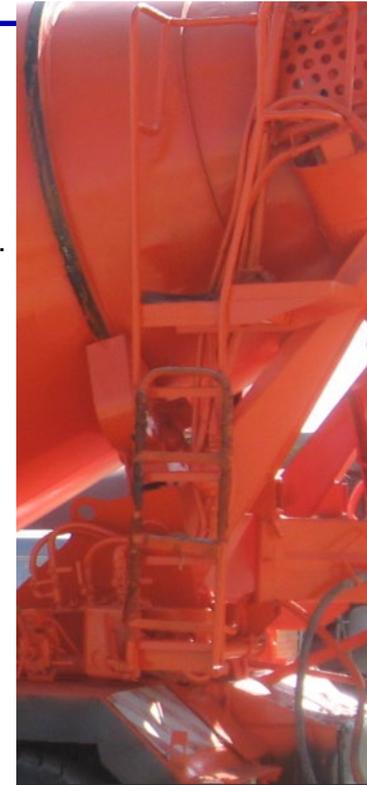
The incident occurred on a rainy day, and the ladder steps were wet. As a result of the fall, the driver sustained a hand fracture.

✓	Contracted driver received the required induction and 3 points of contact training.
✓	Contracted driver received the required PPE and had it with him on the customer site.
✗	Contractor did not use gloves because he claimed that the gloves were wet due to the rain (all other required PPE was used)
	Rainy day – ladder steps were wet and slippery (according to the driver this caused him to lose the grip)
✓	Experienced contracted driver with no previous H&S incidents
✗	According to the contracted driver he used 3 points of contact but lost the grip due to the wet ladder steps
✗	Performance of a non-urgent task at height on a wet ladder during adverse weather

Ladder steps were wet.

- PPE – use of gloves to get a better grip while using the ladder.
- Take 5 – identify the risks before performing the task – wet ladder steps.
- Delay non-urgent work during adverse weather conditions – No ladder climbing for cleaning activities during wet or rainy conditions unless necessary and controlled.

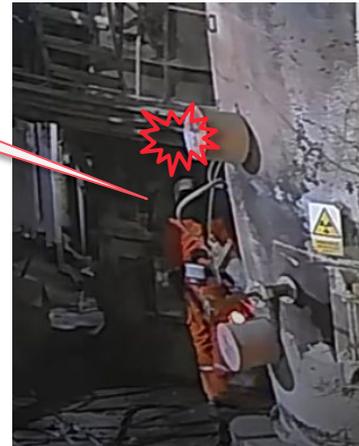
The place of accident

Two Cemex employees were performing regular cleaning of material buildup in PHT. First, the workers attempted to remove the material buildup using a water lance. The material buildup was very hard, and they did not succeed in removing it with the water lance.

Because of this, the worker began removing the material buildup using mechanical tools, in particular a steel bar.

At one point, the material fell and struck the steel bar, which was ejected and hit the worker in the face shield and jaw. No visible injury was detected when first aid was provided, and both workers finished their shift.

✓	The work was qualified for a work activity. The worker participated in all trainings including a practical training at a workplace.
✓	The worker was using proper PPE for this type of activity.
✓	The second worker was involved in the cleaning activity – supported the colleague during using a water lance.
	Using a mechanical tool was allowed according to SOP.
✗	The worker didn't carry out TAKE 5 prior commencing cleaning. No log was found in his notebook from that day (Logs from previous shifts were in the notebook).
✗	The worker was holding the steel bar close to his body, which is against SOP for cleaning PHT.

- Review and update work procedures and SWES for heat exchanger cleaning, and define cleaning methods with consideration of the risks associated with each of them.
- Always carry out a personal risk assessment before the work task when required.
- Replace manual tools used for heat exchanger cleaning, such as rods/tubes, with safer tools from the perspective of grip and handling.

- Conduct practical training sessions for operators on heat exchangers in the presence of production management and the H&S specialist.
- Verify the suitability and adequacy of PPE for work on the heat exchanger.
- Ensure the presence of the shift supervisor during heat exchanger cleaning at least once per shift.
- During discussions within VFL, verify that employees are familiar with and actively apply TAKE 5.
