# Fatal 2 - Mobile Plant - Life changing injuries in telehandler incident – MPConnect Alert

## WHAT HAPPENED

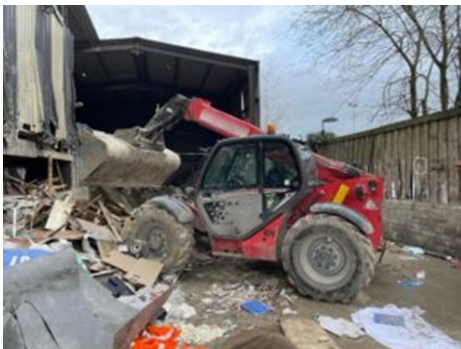
A 21-year-old employee suffered life-changing injuries at a waste and recycling company yard after being crushed against a brick wall by a reversing telehandler. He was hand-sorting waste alongside other workers when the telehandler reversed into him. He sustained **multiple fractures, internal organ injuries, nerve damage, partial hearing loss, and permanent sight loss in one eye.**

- **No suitable and sufficient risk assessment** had been completed for vehicle–pedestrian interactions within the yard.
- **No segregation** between pedestrians and mobile equipment; workers routinely operated on foot in the same areas as vehicles.
- The telehandler had **missing reversing mirrors**, significantly compromising rear visibility.
- The company failed to implement **physical protection or designated pedestrian routes**, placing employees at consistent risk.

- **Effective Traffic Management Plans**, segregate pedestrians and vehicles, and enforce one-way systems and designated equipment operating zones. Apply temporary exclusion zones with barriers when work activities require pedestrian access.
- **Operate documented maintenance schemes**, including **daily pre-use checks**. Rectify defects promptly, especially those affecting visibility.
- **Fit visibility aids where identified by risk assessment**, such as mirrors, cameras, sensors, reversing alarms.
- Ensure all operators are **trained, competent and authorised** and provide periodic refresher training.
- Consider mandating **high-visibility trousers and tops**, not just vests.
- Risk assess all tasks involving **vehicle and pedestrian interaction**.
- **Establish safe zones** where workers can stand when vehicles are moving.

- Review **traffic plans**, ensuring physical segregation where feasible.
- Verify **all mobile equipment has the required visibility aids** and that defects are rectified immediately.
- Reinforce **operator competence** and authorisation procedures.
- Mandate **high-visibility PPE**
- Require **pre task risk assessments** for activities in operational yards.
- Audit compliance regularly, including **daily equipment prestart checks** and pedestrian route adherence.
