### INCIDENT DETAILS

### KEY FINDINGS

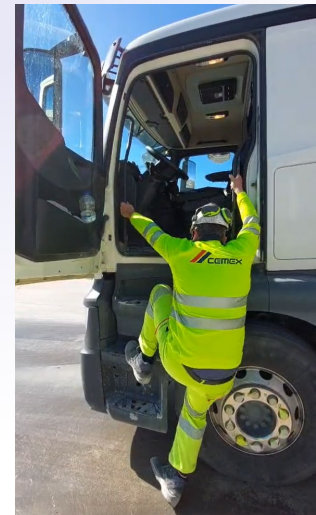
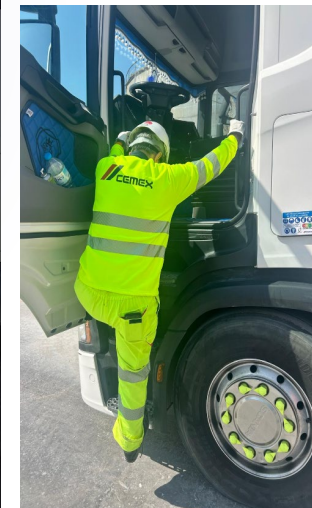
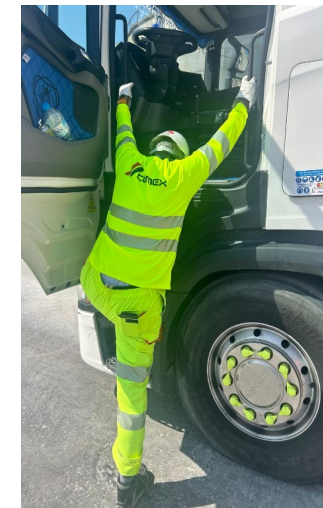
When the driver descended from the cab of the truck, he lost support with his right leg upon stepping onto the first step of the truck. As a result, he fell to ground level, with his body weight impacting the same leg, causing ligament injuries to the knee. The driver stated that he descended using the three points of contact and without haste. The condition of his boots was good, and the truck steps were equipped with anti-slip elements

| ✗ | The driver did not place his foot correctly on the step, which caused the foot to not grip. |

- Remember that when getting in and out of a truck, special attention must be paid to placing the foot fully on each step, avoiding contact only with the toe.
- Before climbing up or down, check the cleanliness of the steps, boots, and grab handles. Remove any debris and ensure the steps are clear of materials.
- Check surroundings, keep hands free, use grab handles, wear proper PPE, and always maintain three points of contact when getting in and out of a truck.
