# Safety Alert

Contractor TRI  
Rental Truck Rollover

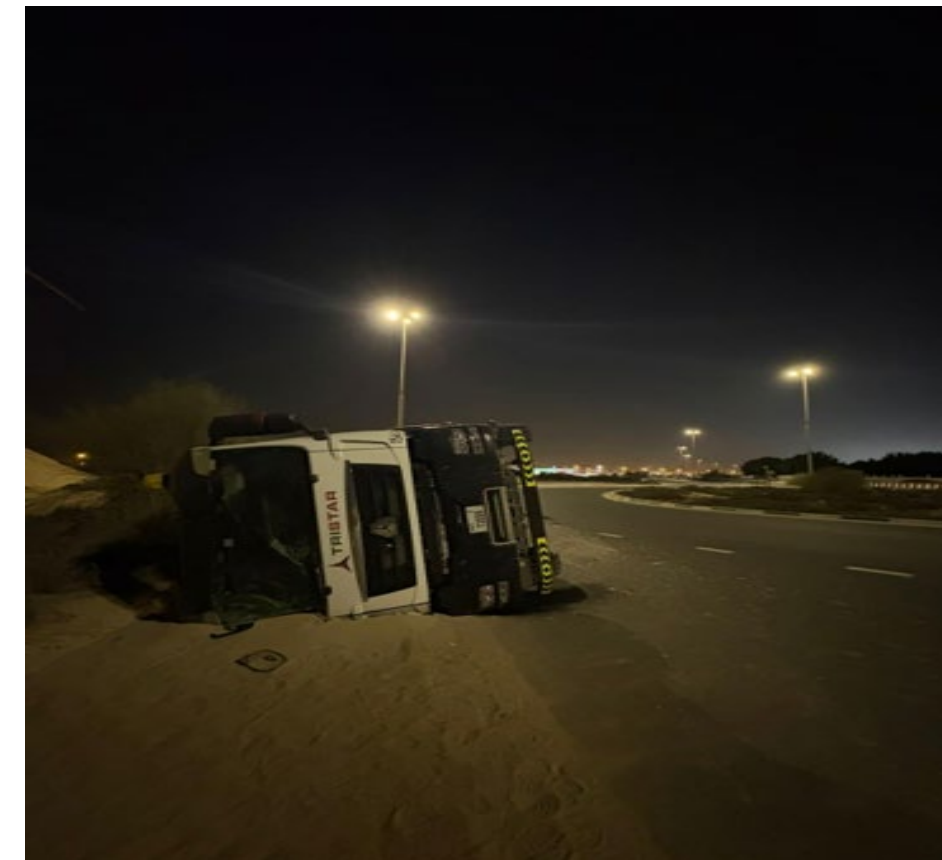
On 22 February 2026, a rented truck mixer carrying a 11 m<sup>3</sup> of concrete rolled over While going to a customer site .The vehicle became unstable during the maneuver after entering the roundabout at a high speed 29km/h, exceeding the safe maneuvering speed.  
As a result of the rollover, the Quality Control Technician who was travelling in the cabin with the driver sustained an elbow injury requiring hospital treatment and stitches

| ✗ | Driver overconfidence influenced the decision to enter the roundabout at high speed. |
| ✗ | The Truck Mixer driver failed to comply with the roundabout speed limit, entering the roundabout at 29 km/h and this confirmed by GPS. |

- Are CEMEX fleet safety standards Applied to all rental trucks and drivers?
- Ensure telematics alerts are active, monitored, and acted upon.
- Review driving violations regularly and address non-compliance promptly.
- Have all drivers completed truck rollover prevention training and behavior monitoring?
