### INCIDENT DETAILS

### KEY FINDINGS

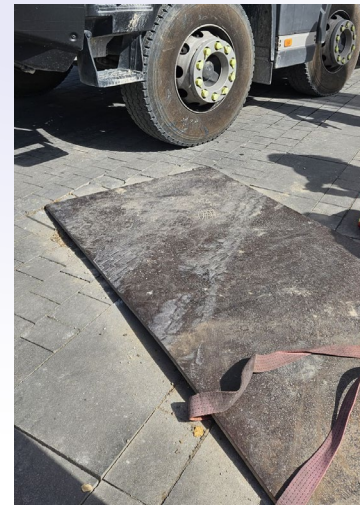
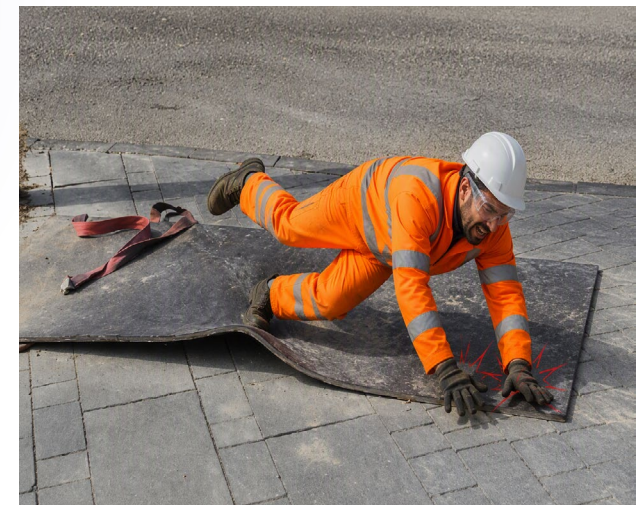
A Readymix truck driver parked the vehicle on the sidewalk within a construction site and exited the cab. After stepping down from the vehicle, the driver walked onto a steel plate installed on the sidewalk. The plate had a slight deformation, causing the driver to lose balance. While attempting to break the fall with both hands, the driver sustained a fracture to a wrist bone. The driver received medical attention and was assigned restricted administrative duties during the recovery period.

| ✗ | The steel plate should not have been located in a pedestrian walkway and showed a slight deformation, which may have contributed to the loss of stability when stepped on. |

- Report any unsafe condition identified on site to the construction site management immediately.
- Remain vigilant when entering or exiting the cab and avoid stepping onto unstable or uneven surfaces.
- Do not use temporary or improvised walkways unless a stable and safe walking surface has been verified.
- Reinforce the “Stop, Think and Act” culture: stop the task, report the hazard, and ensure corrective actions are implemented.
- Promote the use of NMAHs to identify unsafe conditions and improve hazard reporting at customer sites.
- Always assess site specific risks before starting work, particularly when visiting a site for the first time or when conditions have changed.
