SAFETY ALERT

HiPo – BITUMEN PUMP GASKET FAILURE

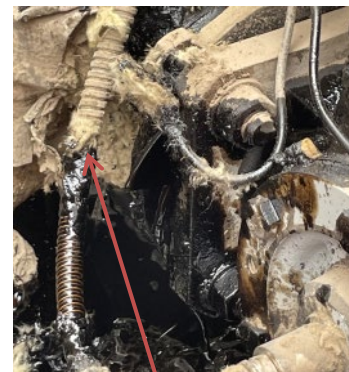
Pipework	The pipes connected to the pump were installed at an angle, which likely complicated the installation of the sealing gaskets during the pump's fitting. Additionally, the pump flange was square while the pipe flange was round, and a portion of the flange had been removed to accommodate the bolts on the side where the failure occurred.
Gasket	The gasket appeared to have been 'pinched' during installation, resulting in a vulnerable area that permitted the gasket to split.
Inspection & Maintenance	The piping and pump have been installed for several years without any problems or indications of malfunction
Air system	The cables and air pipes were raised, apart from one pipe positioned at ground level. This pipe ruptured when it became enveloped in bitumen, resulting in a spray of hot bitumen at an approximate temperature of 135-140 degrees being projected upwards.

Failed gasket

- Assessing the existing condition of equipment, ensuring components are compatible, standardisation of equipment where practical, considering the consequences if a failure was to occur.

- Review bitumen systems to determine if there are water or air pipes situated at ground level that may come into contact with bitumen in the event of a spillage from any section of the system.
- Is the bitumen pump adequately shielded to prevent the outward spraying of bitumen?
- Are all flanges enclosed to prevent bitumen spray in the event of a seal failure?
- Are relevant inspections in place for bitumen systems?
- Are there signs of leaking from pipework?
- It is essential to promptly address and repair any leaking bitumen pipework.
