# SAFETY ALERT

UK SA08/2020 - 19.08.2020

## **MOBILE PLANT OPERATOR TRAPS HAND IN DOOR**

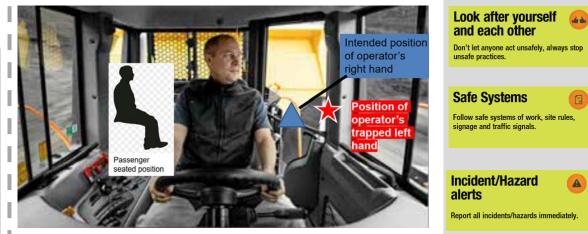
A contractor, who was operating an Articulated Dump Truck (ADT) stopped the vehicle in heavy rain to pick up a pedestrian and transport him to his light vehicle at the base of the guarry. While sitting down in the passenger seat, the passenger closed the door of the ADT; however, the Operator's left hand was on the door frame to assist with leverage (to then reach across with his right hand to pull the door from the seated position). The passenger closed the door, trapping the Operator's hand between door and frame, causing laceration to the Operator's index finger. The Operator attend hospital where his finger nail was removed and stitches applied.

- The risk assessment had not identified this potential hazard.
- The passenger and ADT Operator did not communicate regarding the closure of the door.
- The position of the door handle led Operator to an unusual movement when in seated position.
- The weight of the door required some force to close.

- Brief Operators regarding potential pinch point between door and frame.
- Review risk assessment for access/egress from cab.
- Review pedestrian and vehicle management in changing environments (weather and quarry development).
- Review first aid provisions for access to running water.
- Communication between Operator and passengers.
