GLOBAL SAFETY ALERT

CONTRACTOR FATALLY INJURED

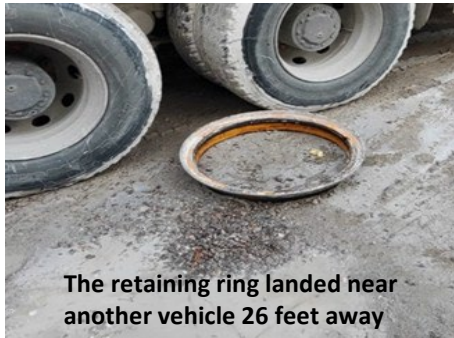
The retaining ring landed near another vehicle 26 feet away

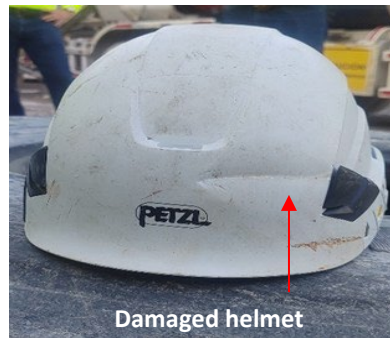
Damaged helmet
